**TRANSPORTATION SCIENCES CENTER  
ACCIDENT RESEARCH GROUP**

**Calspan SRL Corporation  
Buffalo, NY 14225**

**CALSPAN ON-SITE SEAT BELT FAILURE INVESTIGATION  
CALSPAN CASE NO. 94-41  
VEHICLE: 1992 GEO METRO CONVERTIBLE  
LOCATION: SOUTH CAROLINA  
CRASH DATE: [REDACTED] 1994**

1. Report No. 94-41		2. Government Accession No.		3. Recipient's Catalog No.	
4. Title and Subtitle Calspan On-Site Seat Belt Failure Investigation Vehicle - 1992 Geo Metro Convertible Location - South Carolina				5. Report Date: [REDACTED] 1997

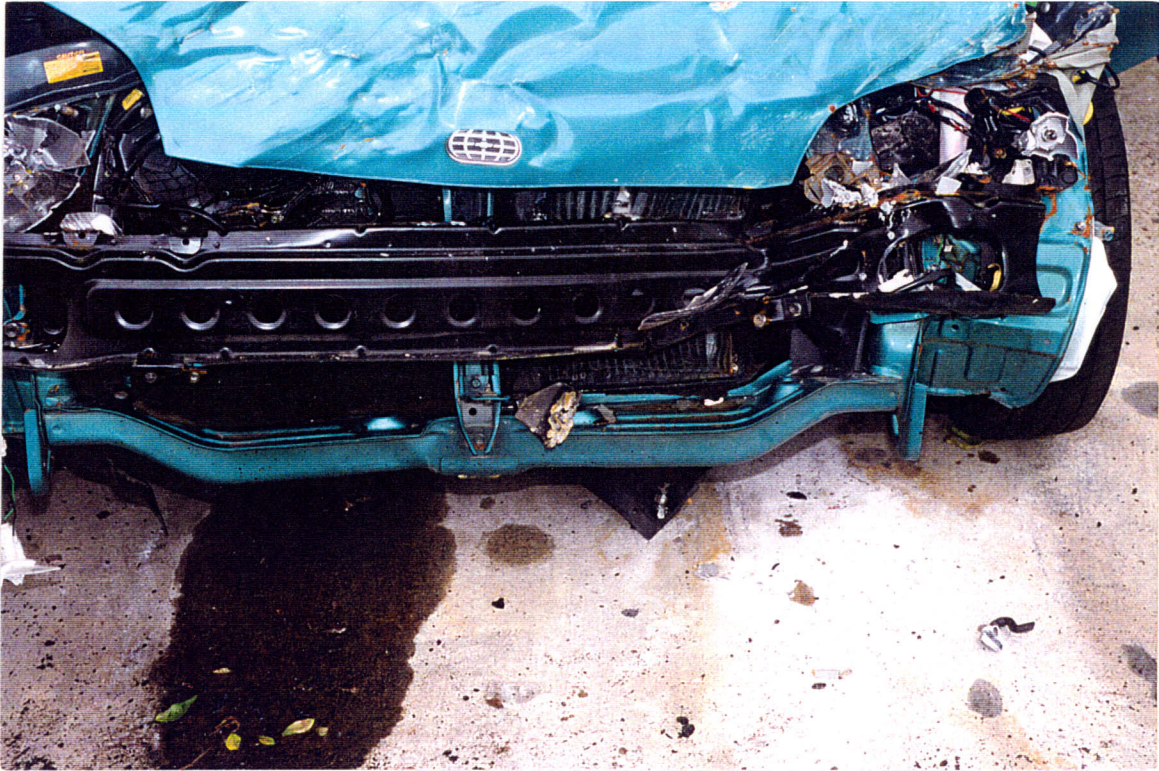
1. Close-up view of the frontal damage to the Geo Metro.

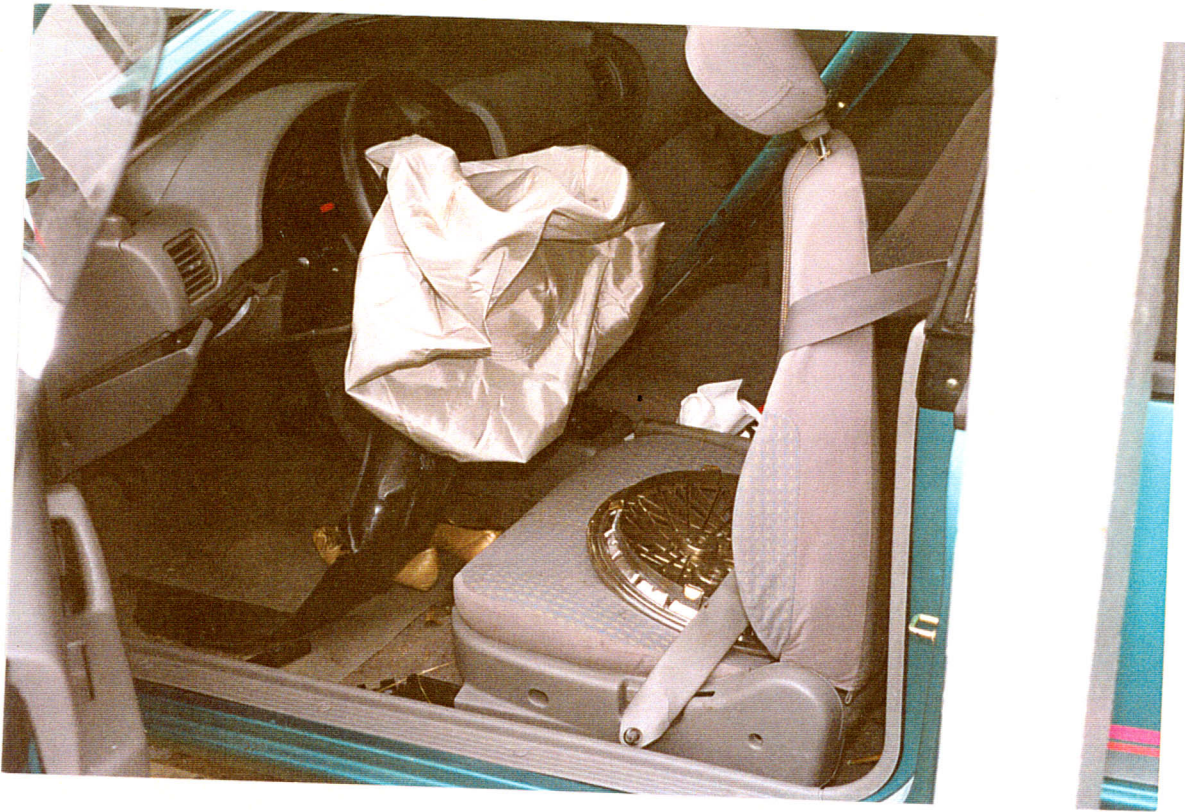
3. Overall interior view of the deployed air bag, deformed seat back, and the separated lower belt anchorage.

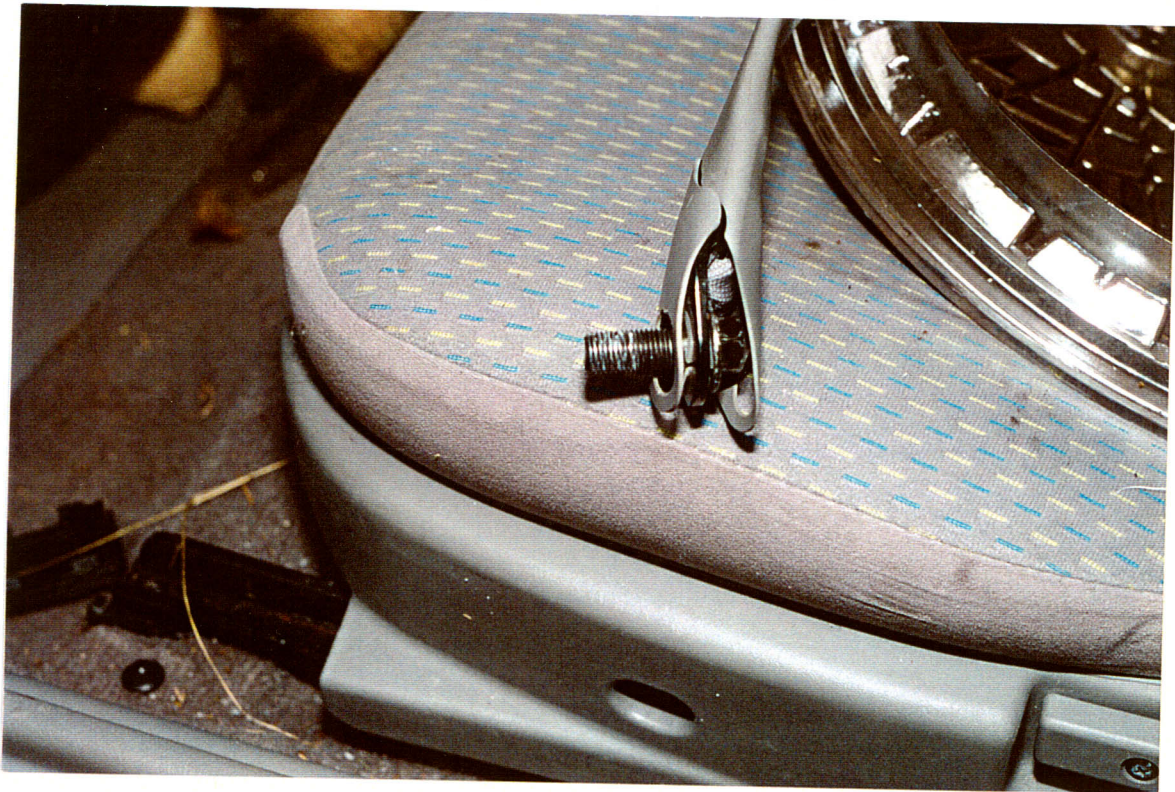
4. Close-up view of the lower anchorage and bolt assembly.

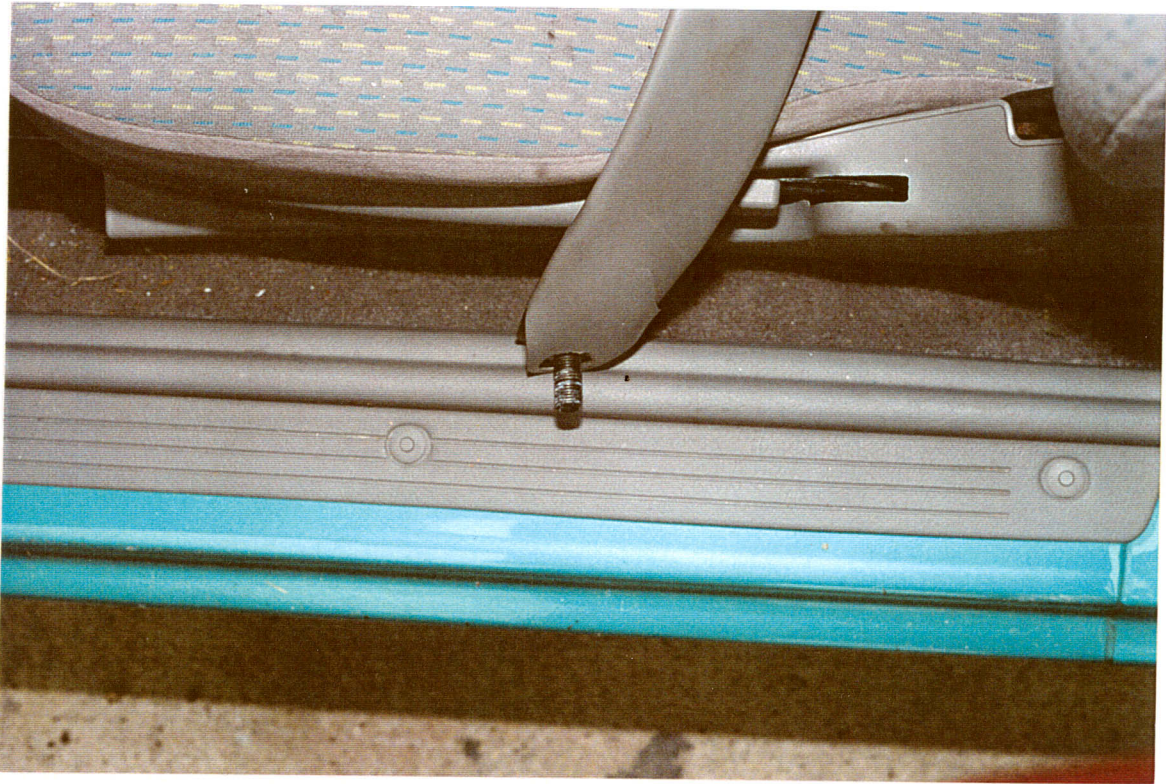
5. Additional view of the separated lower anchorage assembly.

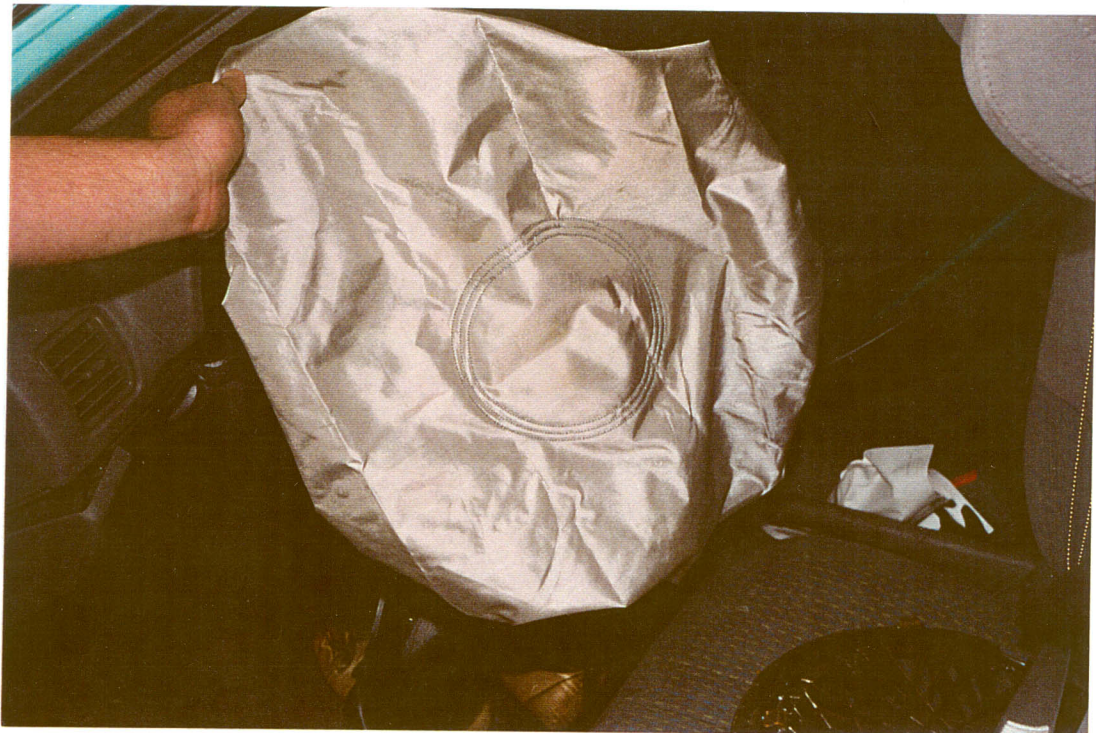
8. Make-up transfers on the deployed driver's side air bag.

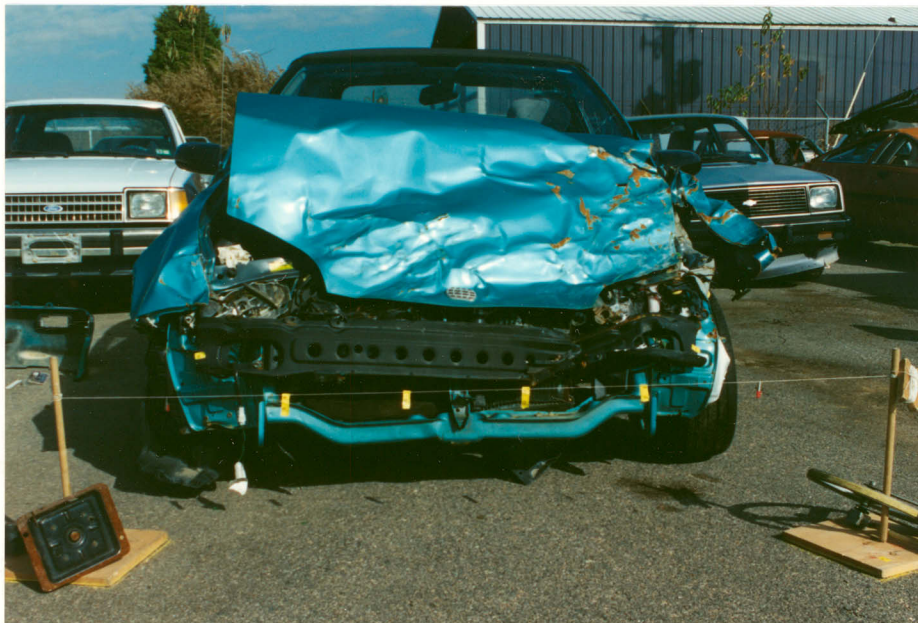
The 1992 Geo Metro sustained moderately severe frontal damage as a result of its front-to-side impact sequence with the Ford Explorer (vehicle #2). The damaged area involved the entire frontal width of the vehicle which included the bumper assembly, grille, hood, both front fenders, and the substructure of the Geo. The impact separated the bumper fascia and the styro-foam filler panel from the bumper reinforcement bar (refer to Photograph Nos. 9 and 10). The direct contact damage was 135.9 cm (53.5") which extended across the full frontal width of the separated fascia. Maximum frontal crush was 43.5 cm (17.1") located 34.3 cm (13.5") inboard of the left front corner of the bumper reinforcement bar (refer to Photograph Nos. 11 through 14). A crush profile was documented at the bumper reinforcement bar which resulted in a measurement damage length (Field L) of 126.7 cm (49.9"). The crush profile was as follows: C<sub>1</sub>=42.2 cm (16.6"), C<sub>2</sub>=42.9 cm (16.9"), C<sub>3</sub>=33.7 cm (13.25"), C<sub>4</sub>=27.0 cm (10.6"), C<sub>5</sub>=23.8 cm (9.4"), C<sub>6</sub>=26.0 cm (10.25"). These values represent the actual residual crush profile with the free space (bumper contour and filler depth) deducted from the field measurements.

8. Frontal damage to the Geo Metro.

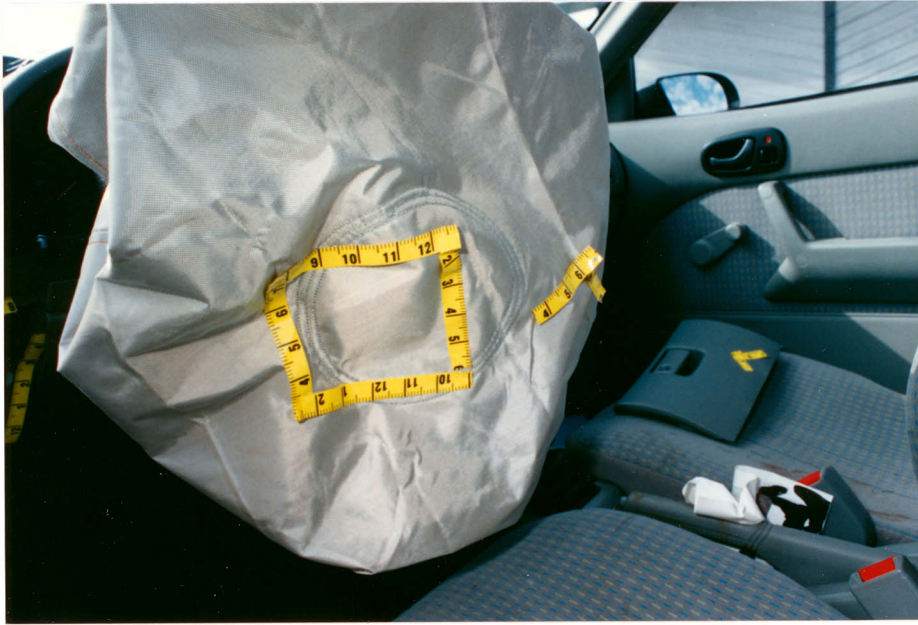
The driver's face contacted the deployed driver's side air bag. Facial contact was evidenced by make-up and lipstick transfers on the bag. A fleshtone make-up transfer was located on the air bag tether reinforcement at 0-6.4 cm (0-2.5") below the horizontal centerline and 1.3 cm (0.5") left to 5.7 cm (2.25") right of the vertical centerline. A faint pink-colored lipstick transfer was noted to the bag at the right upper quadrant, located 10.2-14.0 cm (4.0-5.5") above the horizontal centerline and 9.5-10.2 cm (3.75-4.0") right of the vertical centerline (refer to Photograph Nos. 23 and 24).

23. Close-up view of the driver's side air bag.

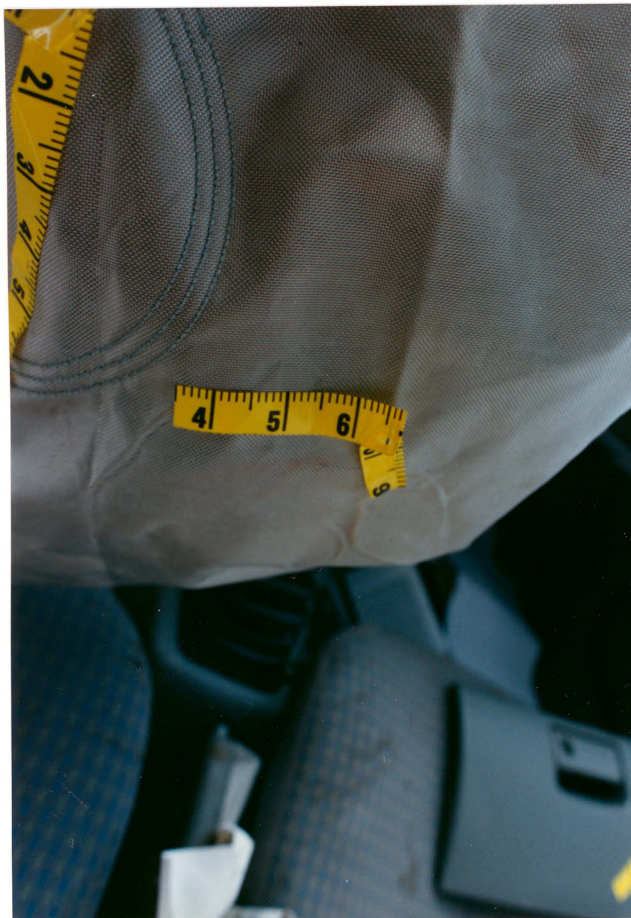
24. Lipstick transfer mark on right upper quadrant of air bag.

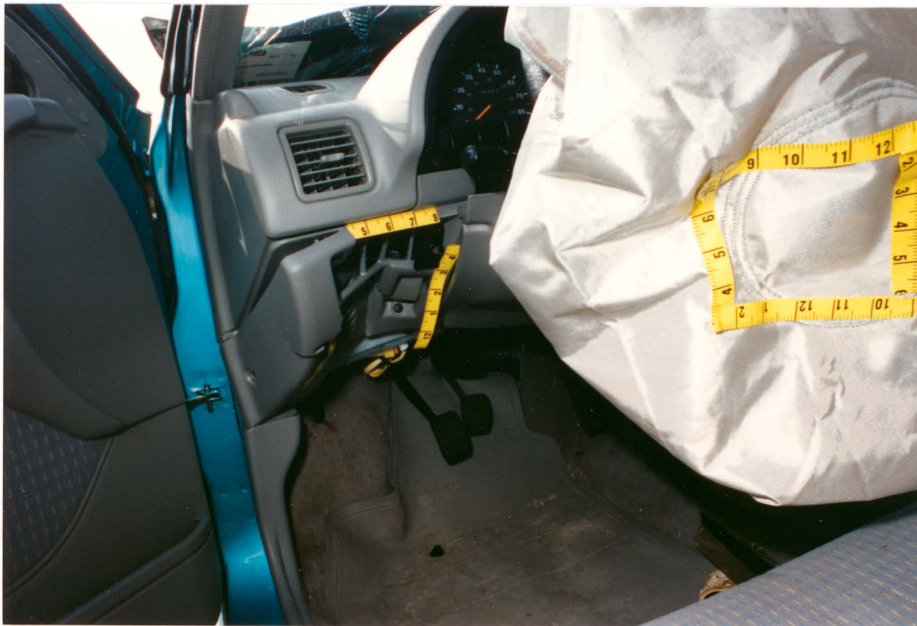
The driver's left knee impacted the mid and lower instrument panel 48.3-61.0 cm (19.0-24.0") left of center and 22.9-38.1 cm (9.0-15.0") below the upper instrument panel. The contact fractured the plastic mid panel and displaced the speaker cover and hood release mechanism approximately 7.6 cm (3.0") forward (refer to Photograph No. 27). The driver's right knee contacted the knee bolster at the base of the steering column (refer to Photograph No. 28). This contact deformed the plastic component and cracked the leading edge of the bolster. In addition, blue denim fabric transfers were present in the in the area of contact which was located 28.0-40.6 cm (11.0-16.0") left of center and 35.6-38.1 cm (14.0-15.0") below the top of the instrument panel.

26. Left knee impact to the left mid instrument panel.

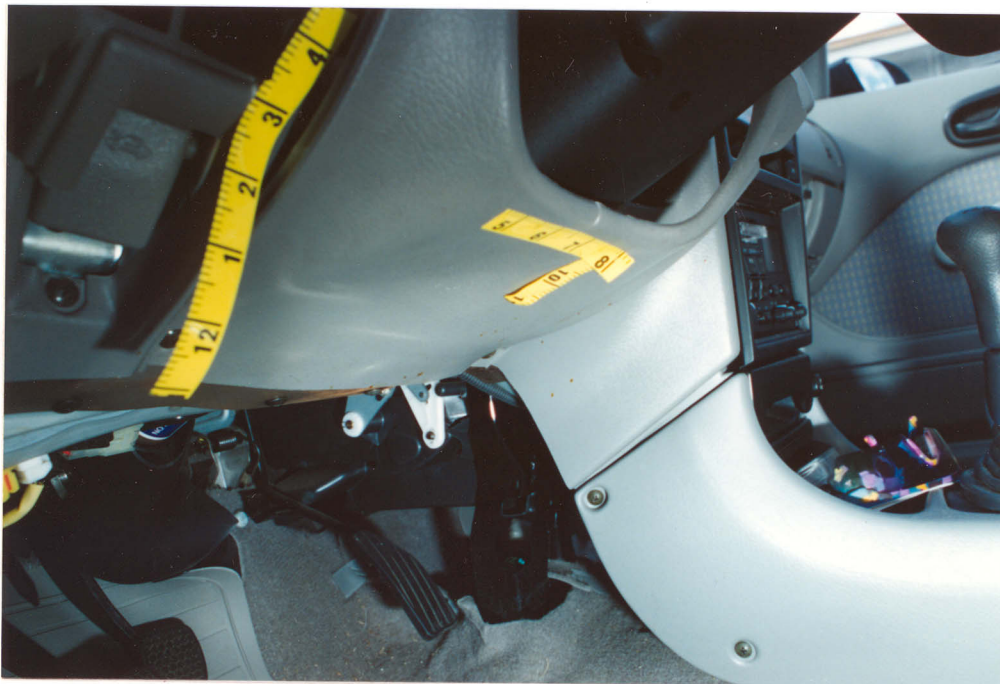
28. Right knee contact to the base of the steering column cover.

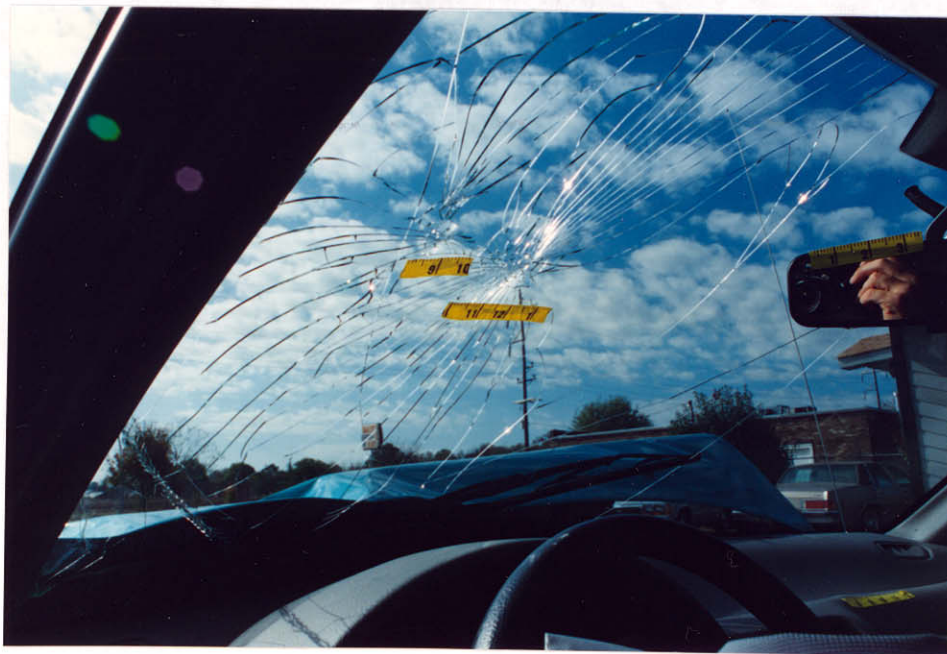
29. Interior view of the driver's side windshield damage.

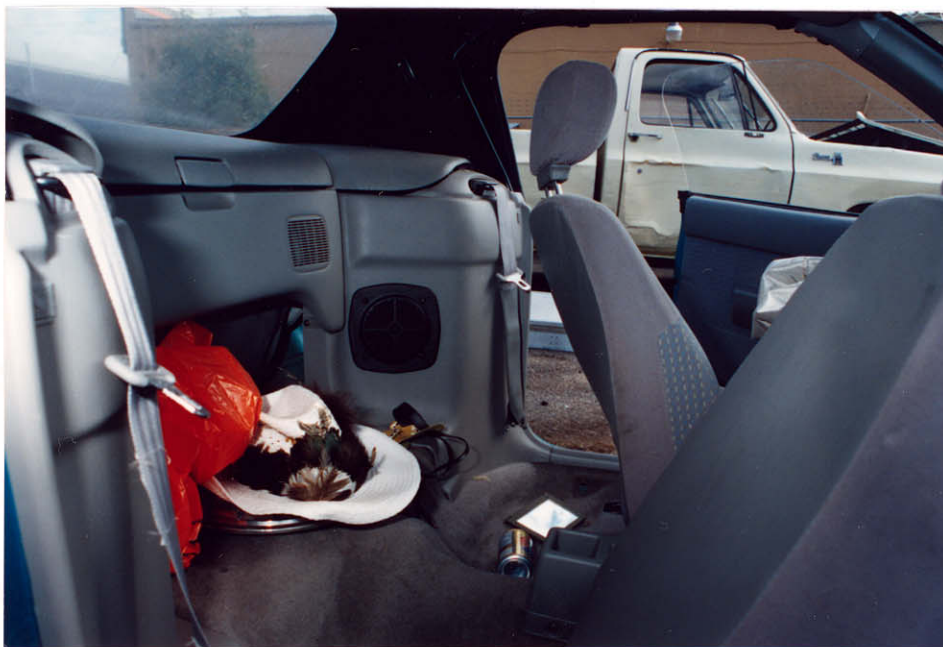
The child occupants positioned in the cargo area of the vehicle, rearward of the front bucket seats, initiated a forward trajectory and loaded the left front seat back, deforming the seat back frame in a counterclockwise direction (refer to Photograph No. 30). One of the child occupants continued forward between the front seat back supports and impacted the padded right upper instrument panel, deforming the panel 22.9-31.8 cm (9.0-12.5") right of the center and 0-10.2 cm (0-4.0") below the top surface of the instrument panel (refer to Photograph No. 44). A scuff mark was noted to the glove box door 3.8-7.0 cm (1.5-2.75") right of the door center and 13.3-16.5 cm (5.25-6.5") below the top of the door. At the time of vehicle inspection, the glove box door was found on the right front floor completely separated from the vehicle as documented in Photograph No. 43.

30. Right side view of the rear storage area behind the front seats and the deformation to the back of the left front seat back.

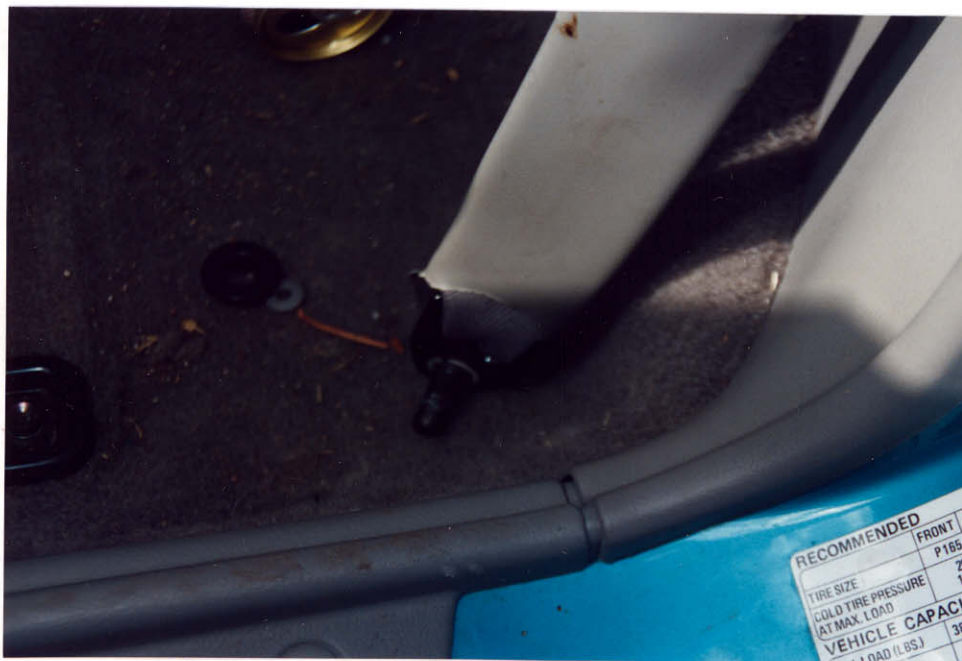
32. View from left side of the driver side lap belt separated from lower anchor point at sill.

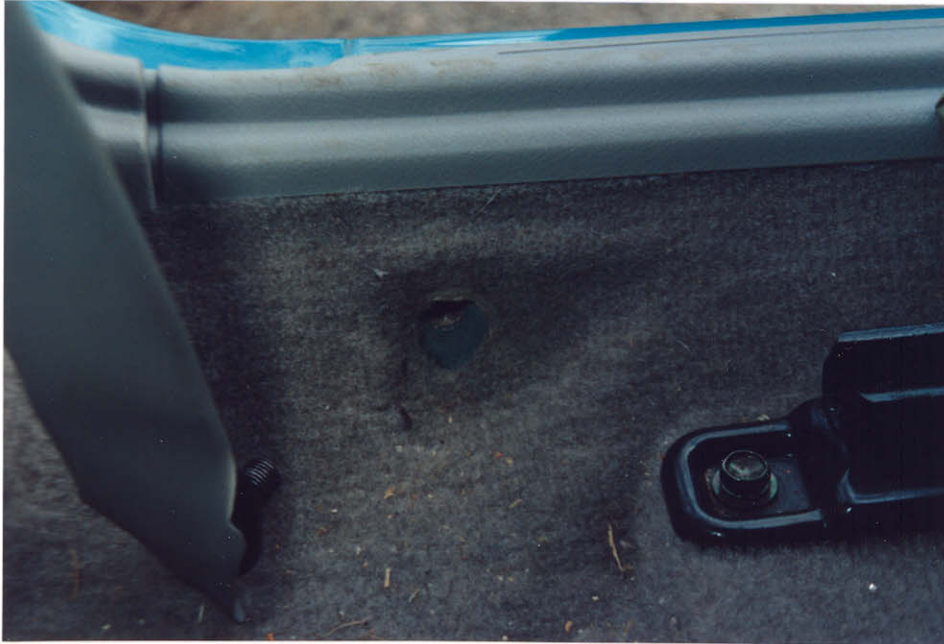
The belt system anchor bolt was threaded into the vertical surface of the sill between the B-pillar and the rear seat track anchorage (refer to Photograph No. 33). The steel sill was reinforced at the location of the bored hole and threaded for the bolt. The edges of the threads in the sill were polished and flattened. It should be noted that the threads within the sill did not appear to be stripped from possible cross threading or over torquing of the bolt.

In the event that the threads were damaged during the assembly process of the vehicle, or that an improper sized bolt or tap was used to thread the hole, normal movement of the belt system through routine usage and access to the cargo area could have backed the bolt out toward the end of the threads, thus separating under occupant loading during the crash. The threaded ends of the bolt and bore did not exhibit a flattening to the end of the threads that would occur from a force applied perpendicular to the bolt length prior to separation (refer to Photograph Nos. 33-40).

33. View from inside of driver seat belt separated from sill.

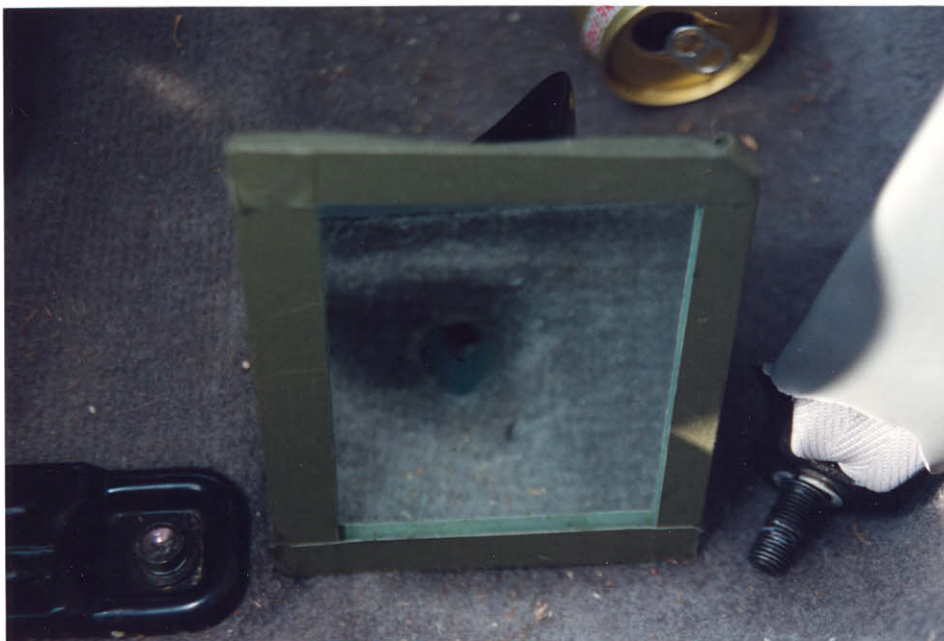
34. Seat belt with anchor bolt (mirror view) and the floor anchorage hole.

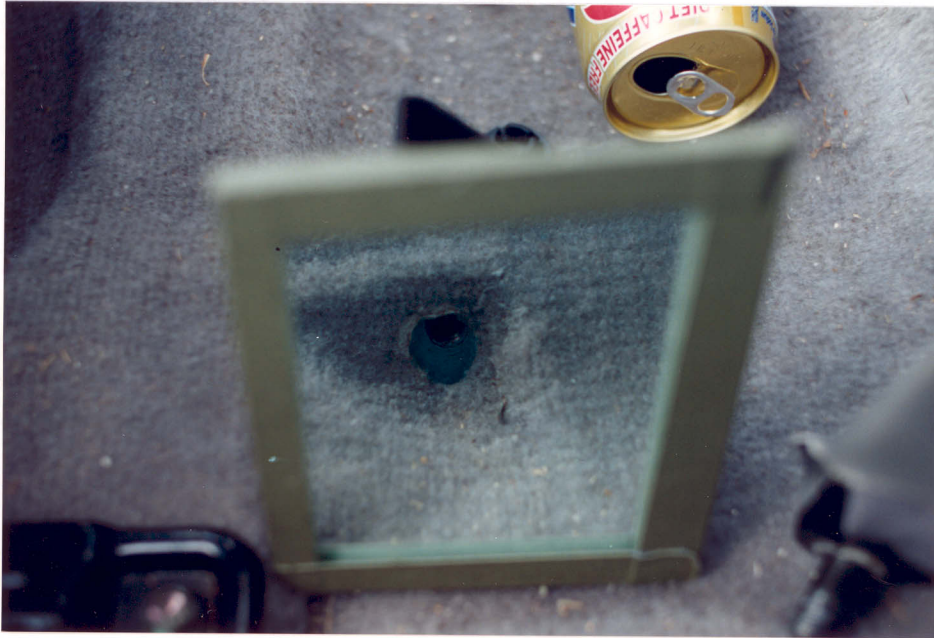
35. View of the floor anchorage hole.

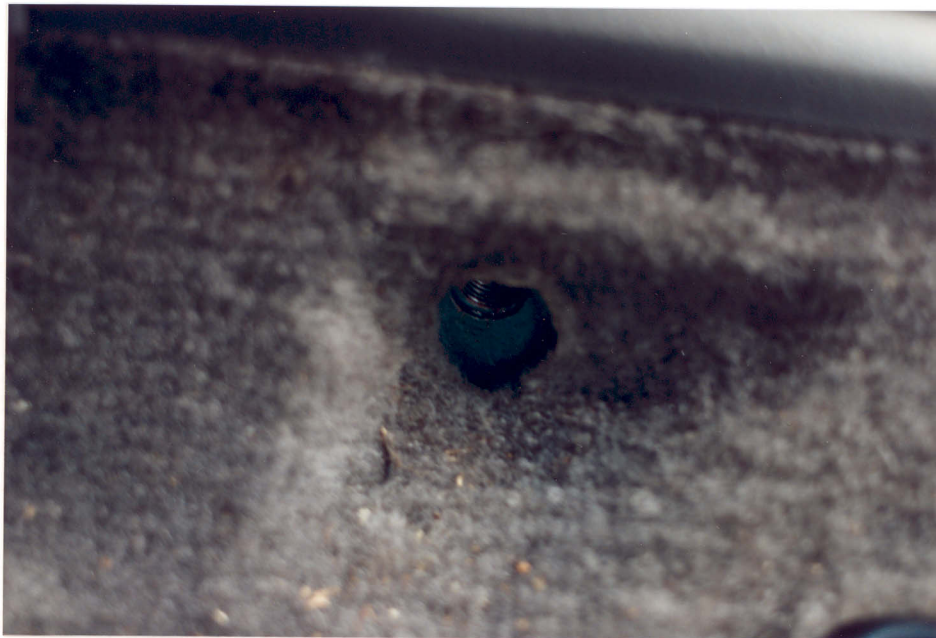
During the on-site investigation, this investigator attempted to re-thread the bolt into the sill. Although the bolt engaged the threads and turned into the sill, the threaded fitment would not securely hold the bolt into the sill. The bolt could be extracted from the sill without rotating the bolt in a counterclockwise direction. A slight side-to-side movement with a pull force parallel to the length of the bolt would separate the bolt from the sill, indicating the bolt was improperly sized for the threaded fitment.

36. Close up view of the stripped threads in the floor anchorage hole.

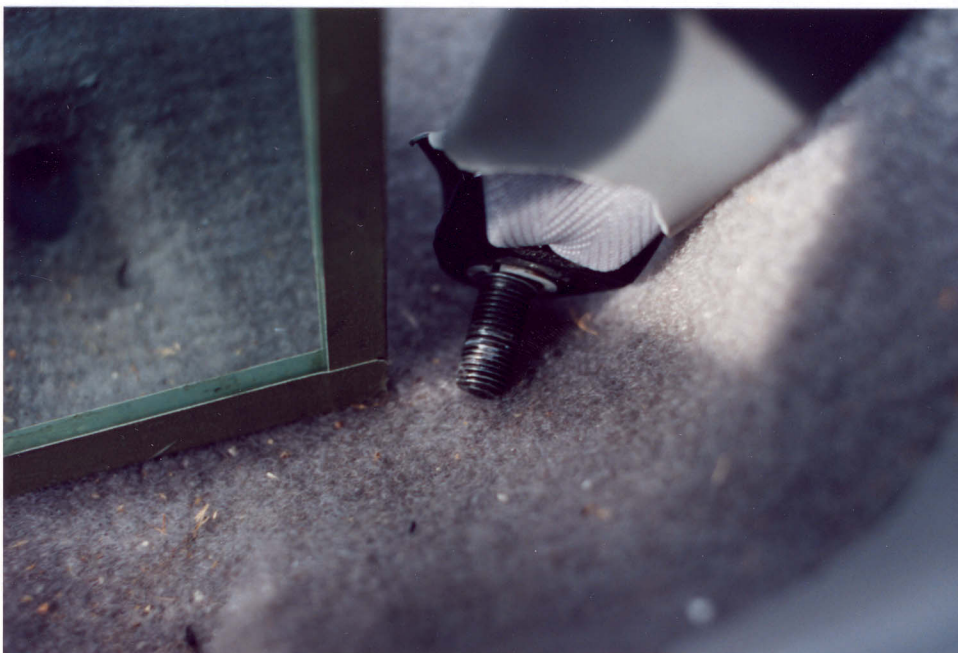
37. Back side view of seat belt anchor bolt in plastic jacket.

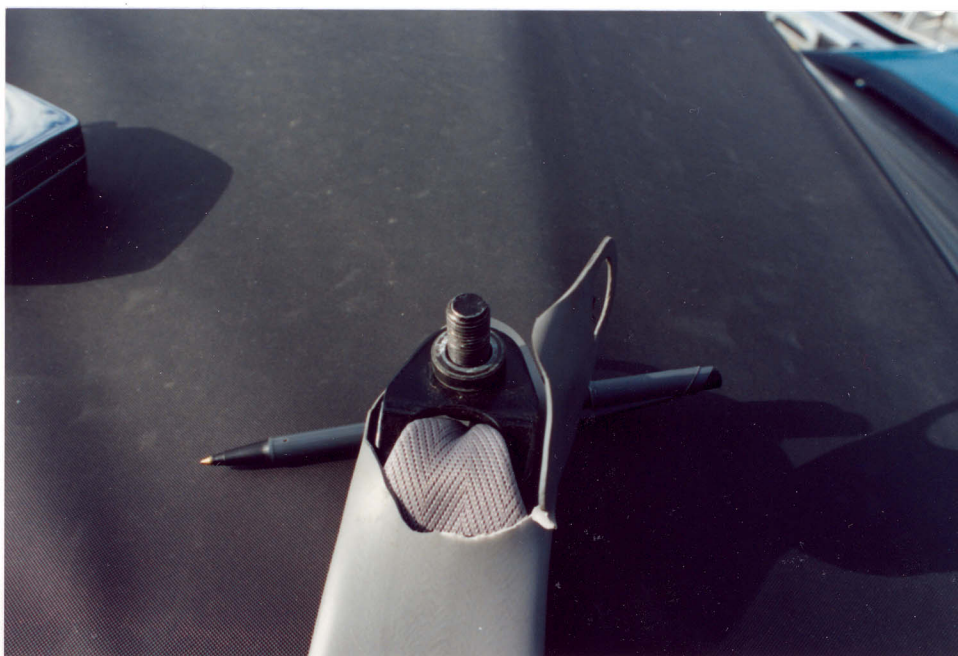
38. Close up view of damage to anchor bolt plastic jacket.

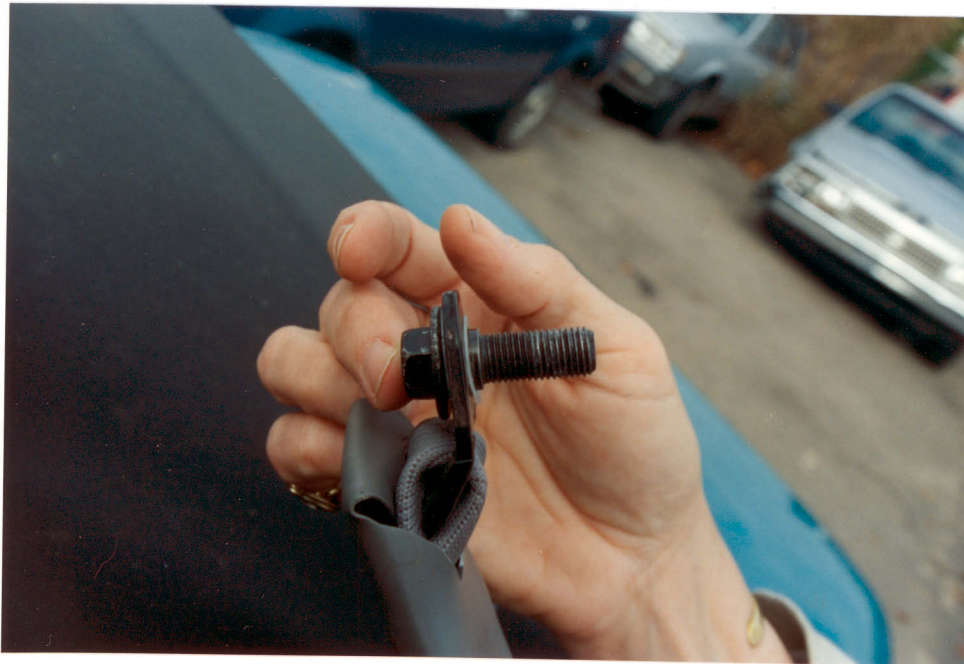
39. Perpendicular view of lower seat belt and anchor bolt assembly.

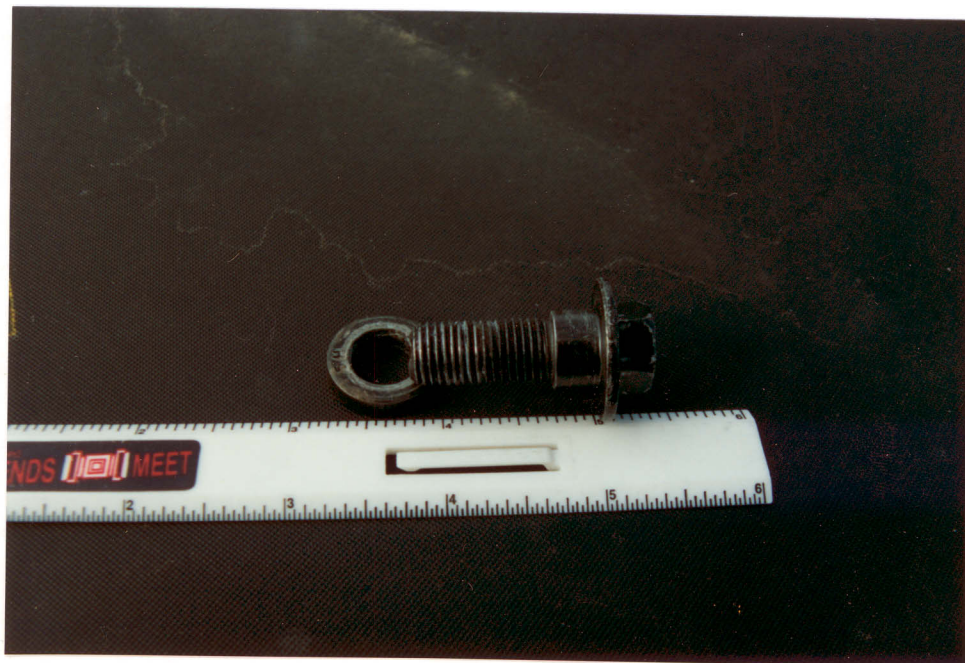
40. Hex head anchor bolt with washer.

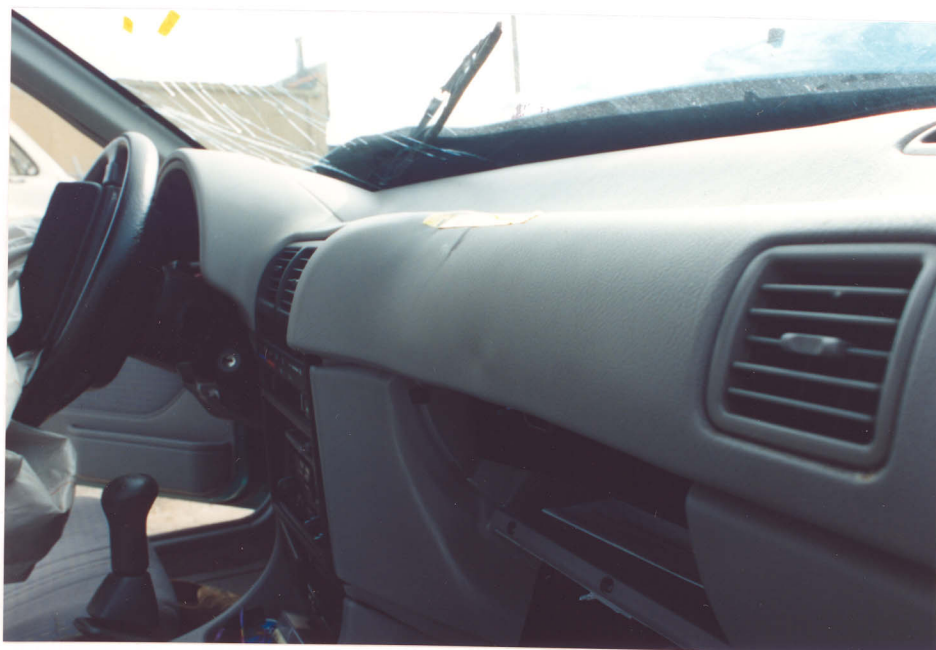
44. Child passenger contact to the right upper instrument panel.

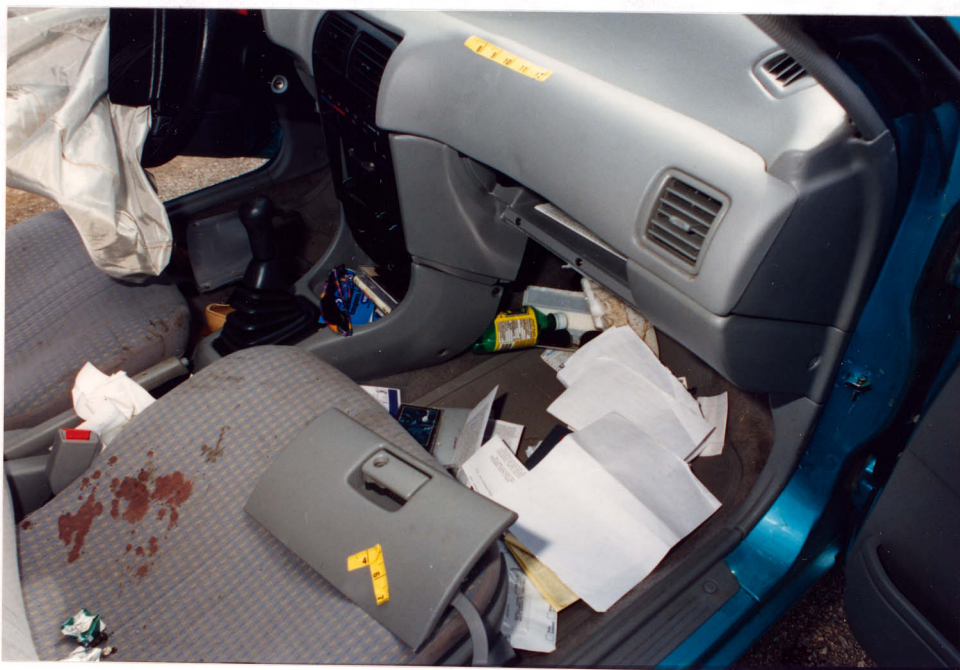
45. View of the separated glove box door.

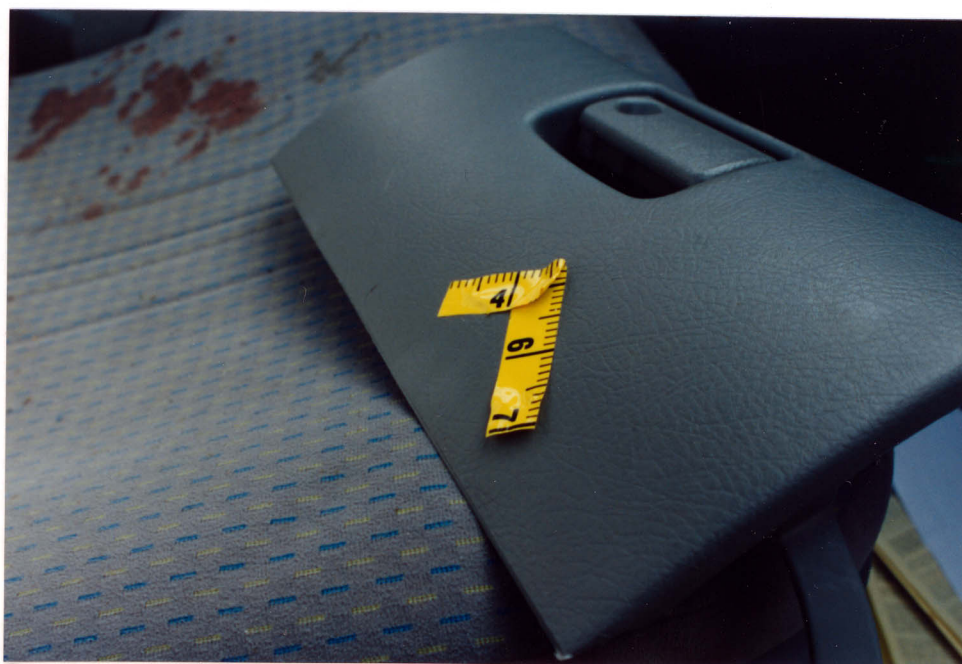
46. Probable child passenger knee scuff on the glove box door.
